# **ANALYSIS OF REMAINS FROM MOUT OLIVE CEMETERY, PORTSMOUTH, VIRGINIA**

**CHICORA RESEARCH CONTRIBUTION 535**

Prepared By:  
Debi Hacker  
and  
Michael Trinkley, Ph.D., RPA

December 29, 2010

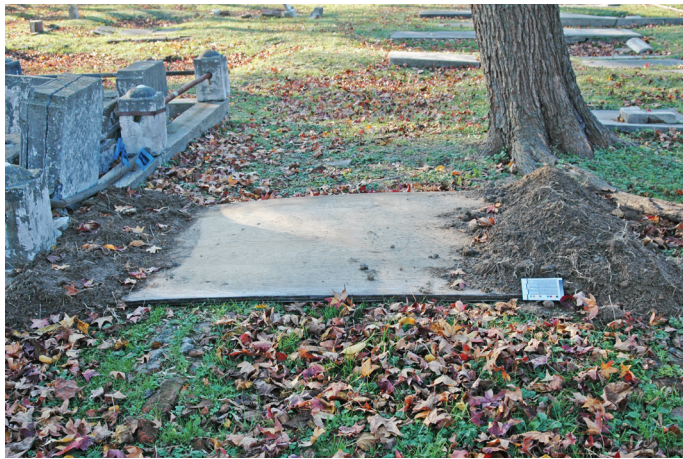
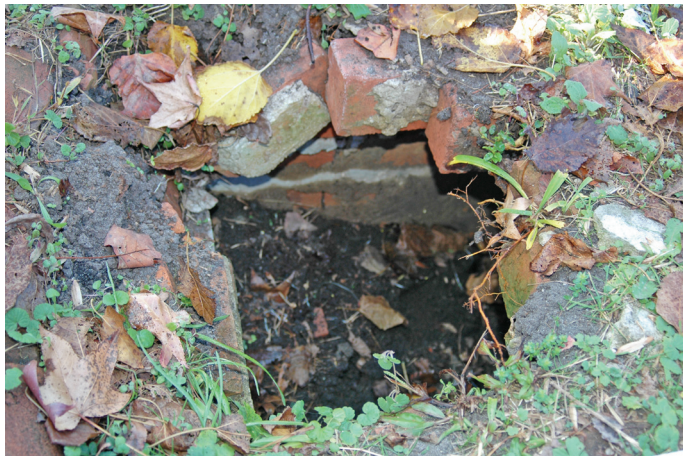
The grave was below ground, in a brick vault with a slightly arched top. The east, or foot of the grave, closest to the coping of an adjacent Mingo family plot, had caved in, exposing the interior.

The grave vault is oriented east-west, and is constructed of brick laid with a cementitious mortar. It measures 30" wide, 72" long, and 24" in height on the east and west walls, with the arch being 26" high. The sides of the vault were originally stuccoed with

Figure 3. Area of vault prior to work. The top photograph shows the plywood covering placed by the City. The bottom photograph shows the collapsed portion of the vault looking east.

Damage is almost certainly the result of several factors. While vaulted, none of the arches observed have any significant mass of masonry on the sides in order to absorb the lateral thrust created by the arches. They are therefore inherently

unstable. Some vaults did not use an arch, but were covered by flat constructions, some of brick (probably originally supported by now decayed wood, perhaps even the shipping container for the casket) or concrete. The very wet conditions in the cemetery are a contributing factor, degrading the mortar and weakening construction. The most significant factor may be the operation of riding mowers in the cemetery. These mowers weight 500 to 800 pounds and use on the vaults is problematical.

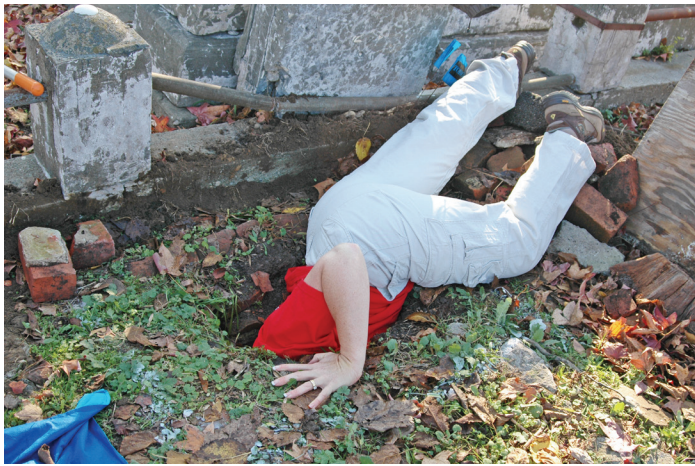
Figure 4. Recovery efforts were hampered by the small opening size. The decision not to expand the opening was made to minimize damage to the vault.

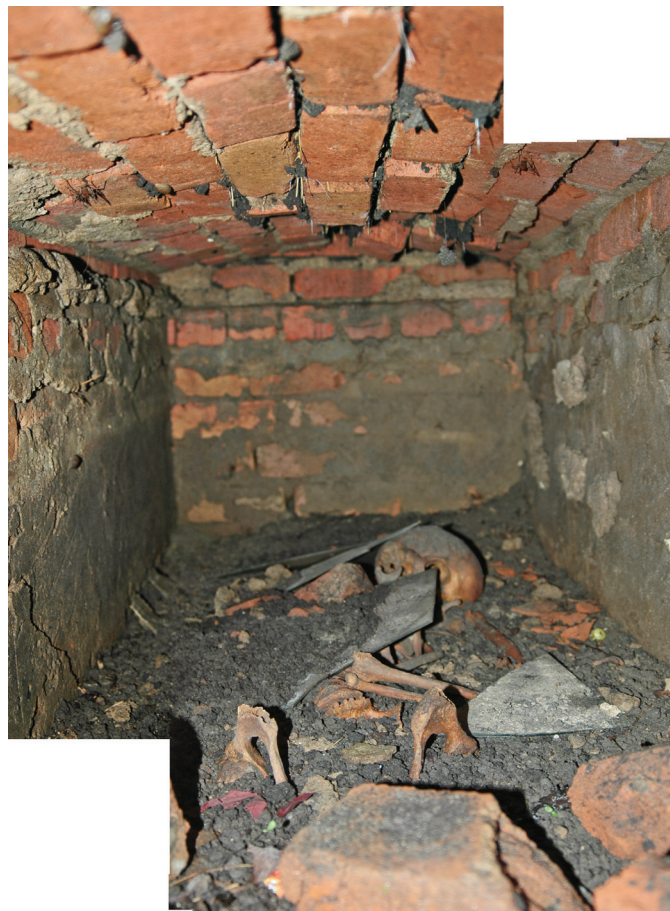
Inside the collapsed vault opening were brick and concrete fragments, tree debris and leaf litter. These were removed and set aside so that the interior of the grave could be viewed. Inside, the grave vault appeared to be in good condition, with the skull, innominate and left long bones visible, as well as coffin hardware and a fragment of viewing glass lying across the skull and ribs. The skull was located at the west end of the grave, resting on its left side. The consensus of

Figure 5. Interior of the vault, looking west.

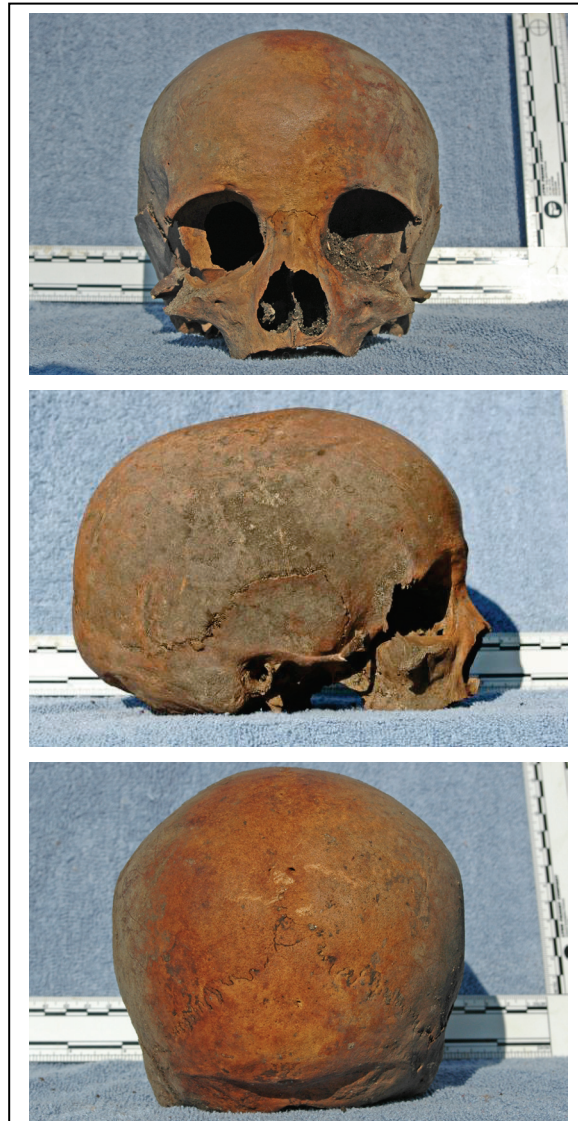
The skull was in stable, good condition, although the zygomatic arches and styloid processes were broken and lost post-mortem. On the skull vault the frontal profile was slightly bossed, there was a slight bunning of the occipital projection, and frontal grooves and post bregma sulcus were evident.

The face was a medium width, with rectangular orbit shape, a projecting maxilla alveolar, wide interorbital distance, and wide nasal bridge and aperture. Although all teeth were missing pre-mortem, the dental arcade was rectangular, and the chin shape was rounded. Based on these morphological attributes, the person appears to be of African descent.

Figure 6. Skull. Top photograph is the front; note rectangular orbit shape, wide interorbital distance, and wide nasal bridge and aperture. Middle photograph is the right side of the skull; note post bregma sulcus, burning of occipital projection, rounded forehead with slight bossing, small orbital ridges, and small mastoid process. Bottom photograph shows the obelion and lambda sutures; note the significant and complete closure.

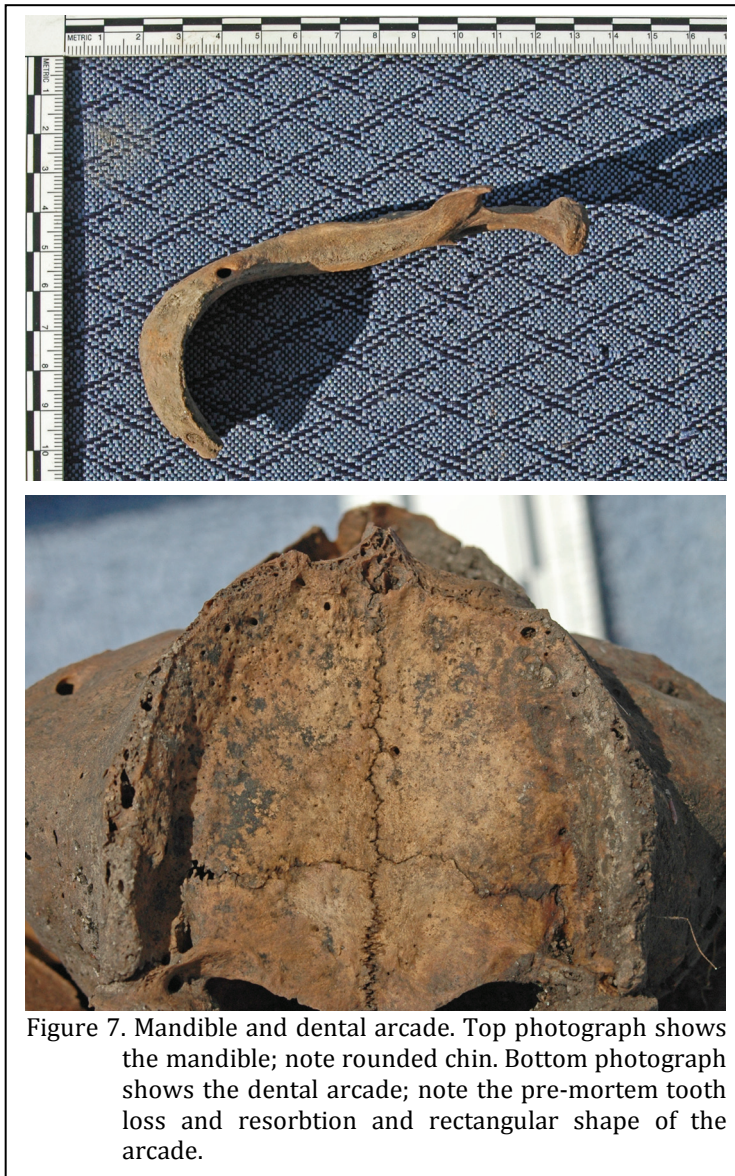
Figure 7. Mandible and dental arcade. Top photograph shows the mandible; note rounded chin. Bottom photograph shows the dental arcade; note the pre-mortem tooth loss and resorption and rectangular shape of the arcade.

The teeth are often examined for age estimates. In this case, all teeth were lost pre-mortem, for at least 10 years, based on the total resorption and loss of mandibular bone. The mandible bone loss is of such an extent that the bone ridge is very close to the mental foramen. Being edentulous for such a long period would have had an effect on this individual's eating habits and diet (Larsen 1997:78).

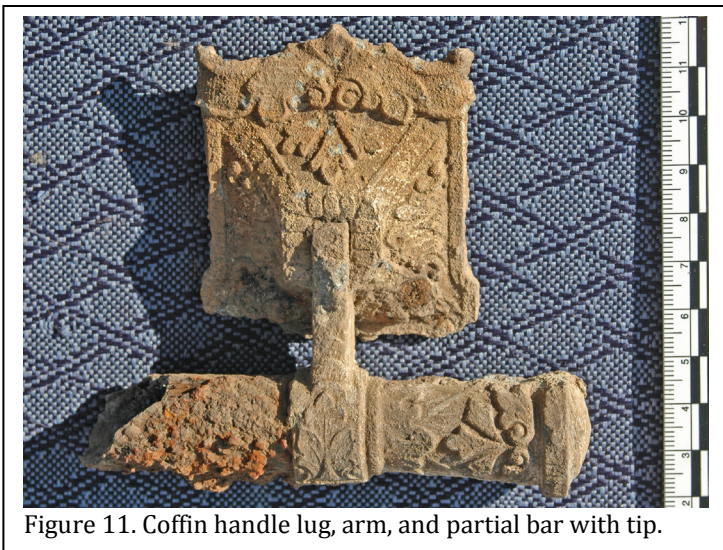
The item recovered was a portion of a short bar handle consisting of the lug, arm, a fragment of the bar, and tip. The lug is a white metal, and the bar is a plated ferrous metal over a wood core.

Figure 11. Coffin handle lug, arm, and partial bar with tip.
